**Technical Report – R4790888868-2  
BS 6375-1:2015+A1:2016  
Performance of Windows & Doors,  
Classification and Guidance for  
Weather Tightness Annual Audit**

**Vista Panels  
Vista Panels, Xtreme and  
Dales Composite Doors**

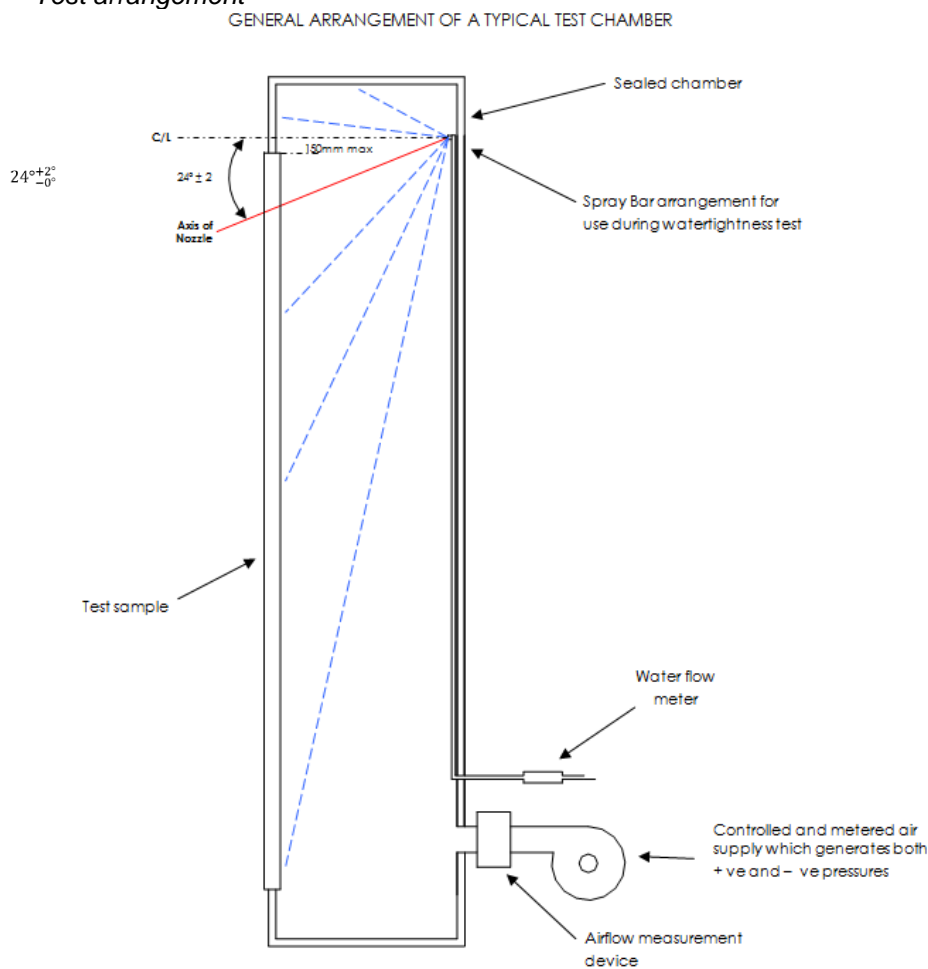
Figure 1 – Test arrangement

A window specimen, supplied for testing in accordance with the relevant British and European Standards, was mounted into a rigid test chamber. The pressure within the chamber was controlled by means of a centrifugal fan and a system of ducting and valves. The static pressure difference between the outside and inside of the chamber being measured by means of a pressure transmitter.

The spray nozzles have a circular full cone spray pattern and a spray angle of  $120^\circ (+0^\circ/-10^\circ)$  at working pressure of 2 – 3 bar and a flow rate of 2 litres/min ( $\pm 0.2$  litres/min) per nozzle. The nozzles were spaced at 400 mm ( $\pm 10$ mm) along the axis of the spraybar and the nozzles were arranged so that the lateral distance between the outer edge of the surround and the outermost nozzles shall be greater than 50mm but not exceeding 250mm.

The nozzle line was located not more than 150mm above the topmost horizontal joint line of any moving frame or the glazing line of any fixed glazing, in order to provide complete wetting of the adjacent horizontal frame member(s). The nozzle line was also located at a distance of 250mm ( $+10$ mm/- 0mm) from the external face of the specimen as defined by the outermost external joint plane of moving parts or the glazing plane of fixed parts.

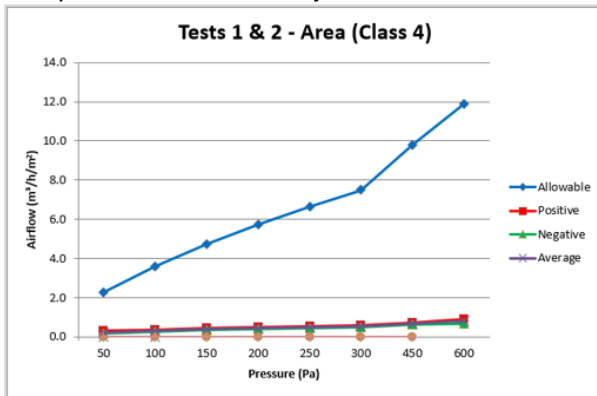
Graph 1 – Air Permeability – Area

Pressure Differential Pa	Air Permeability Rate Infiltration & Exfiltration Tests m <sup>3</sup> /hr/m <sup>2</sup> - Area			Air Permeability Rate Infiltration & Exfiltration Tests m <sup>3</sup> /hr/m - Length of Joint		
	Test No. 1	Test No. 2	Average	Test No. 1	Test No. 2	Average
50	0.30	0.16	0.23	0.11	0.06	0.09
100	0.37	0.27	0.32	0.14	0.10	0.12
150	0.45	0.33	0.39	0.17	0.13	0.15
200	0.50	0.39	0.44	0.19	0.15	0.17
250	0.54	0.44	0.49	0.21	0.17	0.19
300	0.58	0.47	0.53	0.22	0.18	0.20
450	0.73	0.61	0.67	0.28	0.23	0.26
600	0.90	0.68	0.79	0.34	0.26	0.30

Based on Area	Based on Length of Opening Joint
4	4
Overall class	
4

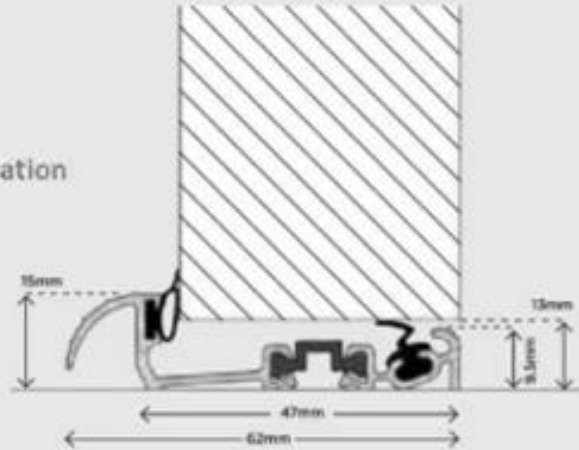
## MXS 15/2 RITB

Inward Opening  
Available in Gold & Mill Finish  
Part M Compliant  
Thermally Broken Prevents Condensation
