Technical Report – R4790261459-1 PAS 24:2016 - Enhanced security performance requirements for doorsets and windows in the UK

> Vista Panels Single Inward Opening Composite Door

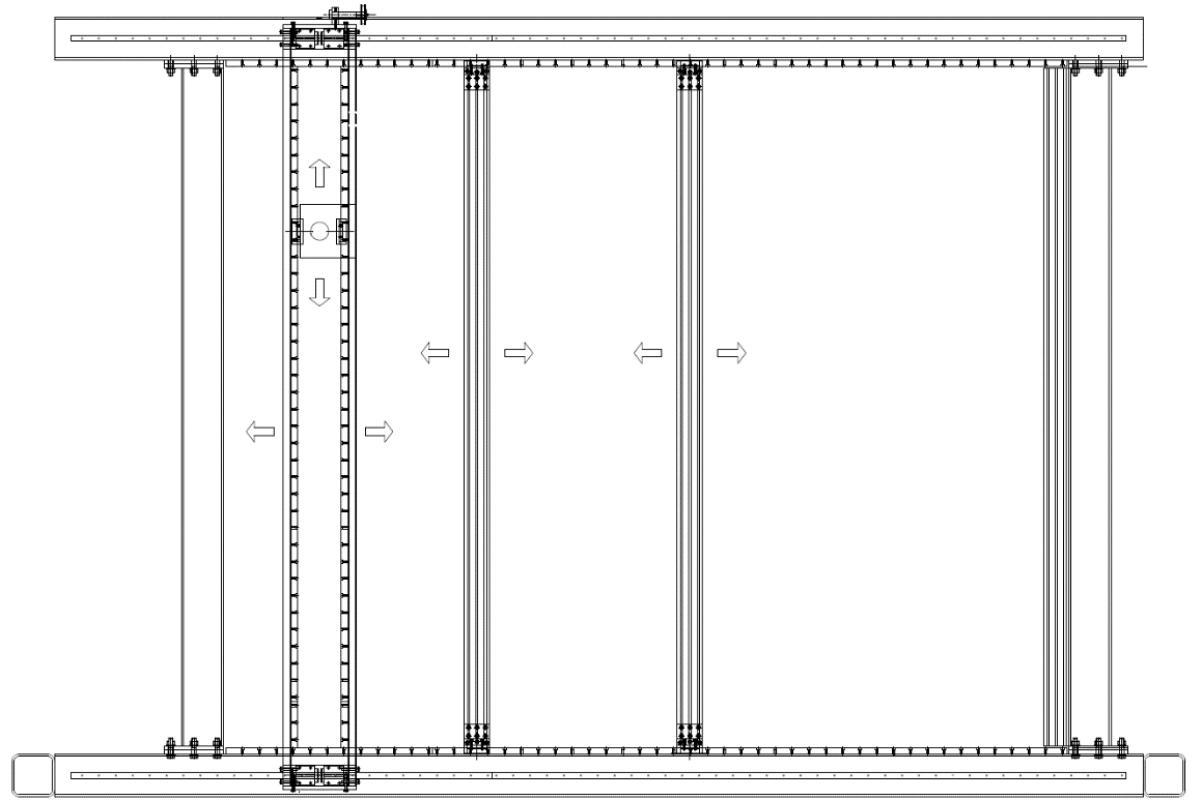
The test sample was supplied mounted in 100×50 mm timber sub-frame in accordance with manufacturer's installation requirements. It was fitted into the test rig, shown below which was constructed to meet the requirements of the test specification and was fitted plumb, square and without twist or bends.

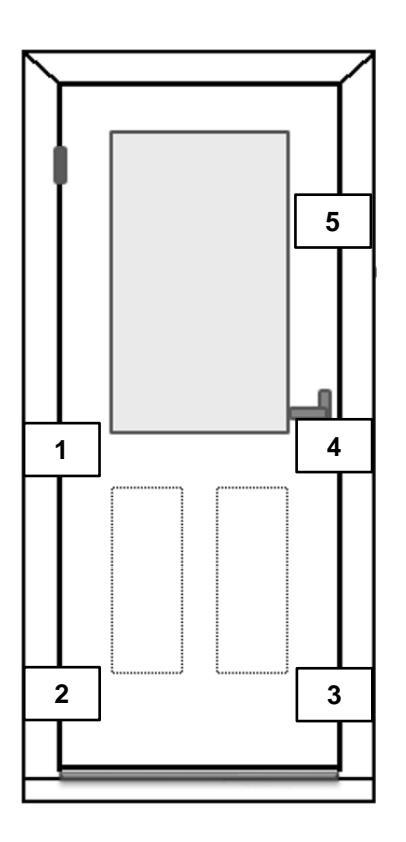
Location	Tools Used	Method	Time	Entry gained
1 – Hinge	x2 Paint scrapers	The paint scrapers were used to lever between the frame and the leaf in an attempt to manipulate the hardware.	03:00	No
2 – Hinge	x2 Paint scrapers	The paint scrapers were used to lever between the frame and the leaf in an attempt to manipulate the hardware.	03:00	No
3 – Double Hook	x2 Paint scrapers	The paint scrapers were used to lever between the frame and the leaf whilst attempting to manipulate the locking hardware.	03:00	No
4 – Hook	x2 Paint scrapers	The paint scrapers were used to lever between the frame and the leaf whilst attempting to manipulate the locking hardware.	03:00	No
5 – Double Hook	x2 Paint scrapers	The paint scrapers were used to lever between the frame and the leaf whilst attempting to manipulate the locking hardware.	03:00	No

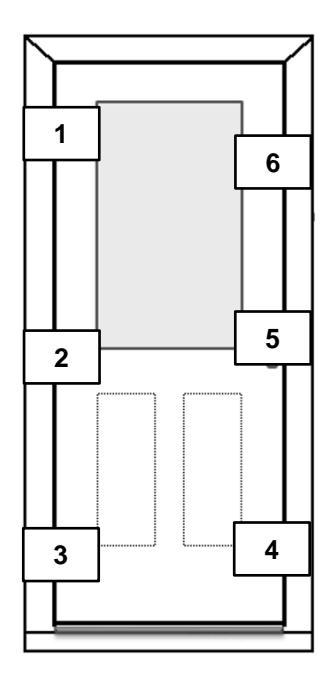
Figure 3 - Loading points

A series of loads were applied to the internal face of the sample as defined in Section B.4.5 of PAS 24:2016. The loading combinations used were as defined in Table B.1 to Table B.6 of PAS 24:2016 for the applicable door type and as shown in Table 2. The results are as follows:

Loading Point	Parallel-to-plane Load		Perpendicular-to-plane Load		Result
	Load (kN)	Direction	Load (kN)	Direction	
1 – Hinge	1.5	\rightarrow	4.5	-	Pass
2 – Hinge	1.5	\rightarrow	4.5	-	Pass
3 – Hinge	1.5	\rightarrow	4.5	-	Pass
4 – Double Hook	1.5	\downarrow	4.5	-	Pass
4 – Double Hook	1.5	↑ (4.5	-	Pass
4 – Double Hook	1.5	←	4.5	-	Pass
5 - Hook	1.5	↑ (4.5	-	Pass
5 – Hook	1.5	←	4.5	-	Pass
6 – Double Hook	1.5	↑ (4.5	-	Pass
6 – Double Hook	1.5	Ļ	4.5	-	Pass
6 – Double Hook	1.5	←	4.5	-	Pass

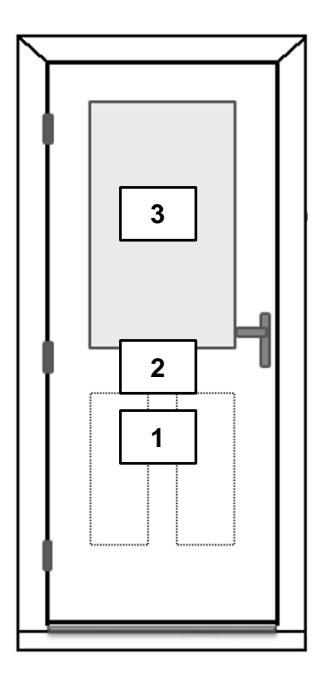
Figure 4 – Impact locations

The test sample was subject to soft body impacts on the external face as shown in Figure 4. Each of the locations was subject to 3 impacts from a drop height of 800mm, following which no damage was observed.

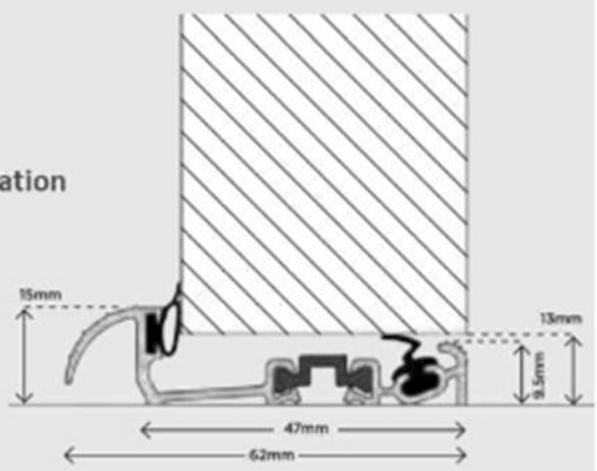
MXS 15/2 RITB

Inward Opening Available in Gold & Mill Finish Part M Compliant Thermally Broken Prevents Condensation
