PAS 24:2022 - Enhanced Security Performance Requirements for Doorsets and Windows in the UK

Vista Panels

Test Report No. R4791793030-1

2 December 2025

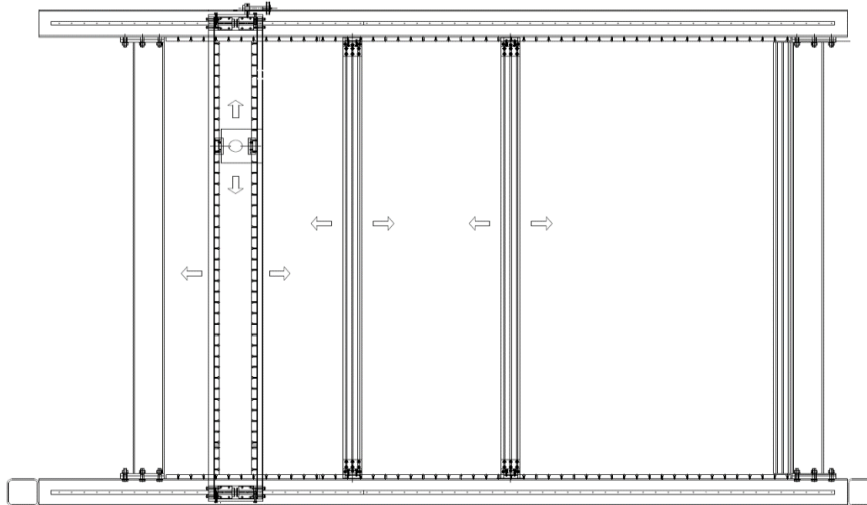
Figure 1 – Test rig used for testing

The test sample was supplied mounted in a 75x95 mm Timber sub-frame in accordance with manufacturer's installation requirements. The sample was installed into the test rig, which was constructed to meet the requirements of the test specification, and was installed plumb, square and without twist or bends.

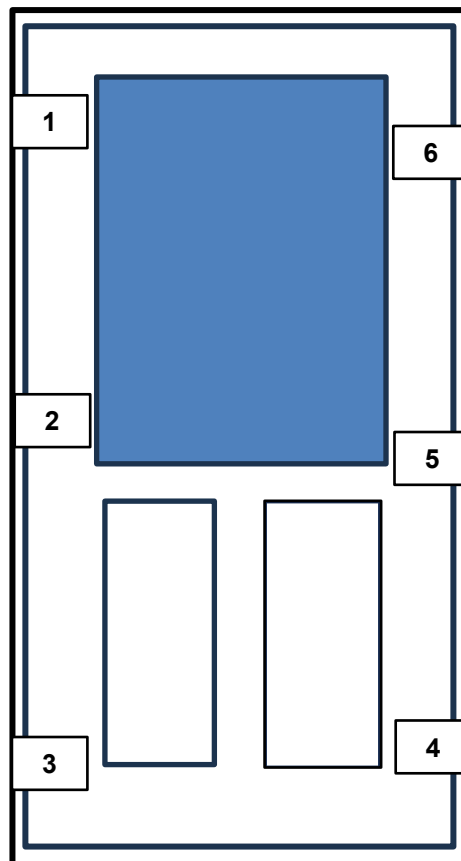
Figure 2 – Loading points

A series of loads were applied to the door leaf as defined in section B.4.5 of PAS 24:2022. The loading combinations used were as defined in table B.1 to table B.6 of PAS 24:2022 for the applicable door type and were applied as shown in table 2. The results are as follows:

Loading point		Parallel-to-plane load			Perpendicular-to-plane load			Result
		Target (kN)	Applied (kN)	Direction	Target (kN)	Applied (kN)	Direction	
1	Hinge	1.5	1.542	→	4.5	4.436	-	Pass
2	Hinge	1.5	1.558	→	4.5	4.424	-	Pass
3	Hinge	1.5	1.514	→	4.5	4.462	-	Pass
4	Double Hook	1.5	1.526	↓	4.5	4.412	-	Pass
4	Double Hook	1.5	1.550	↑	4.5	4.442	-	Pass
4	Double Hook	1.5	1.500	←	4.5	4.424	-	Pass
5	Hook	1.5	1.540	↑	4.5	4.480	-	Pass
5	Hook	1.5	1.482	←	4.5	4.416	-	Pass
6	Double Hook	1.5	1.530	↓	4.5	4.470	-	Pass
6	Double Hook	1.5	1.530	↑	4.5	4.404	-	Pass
6	Double Hook	1.5	1.490	←	4.5	4.428	-	Pass

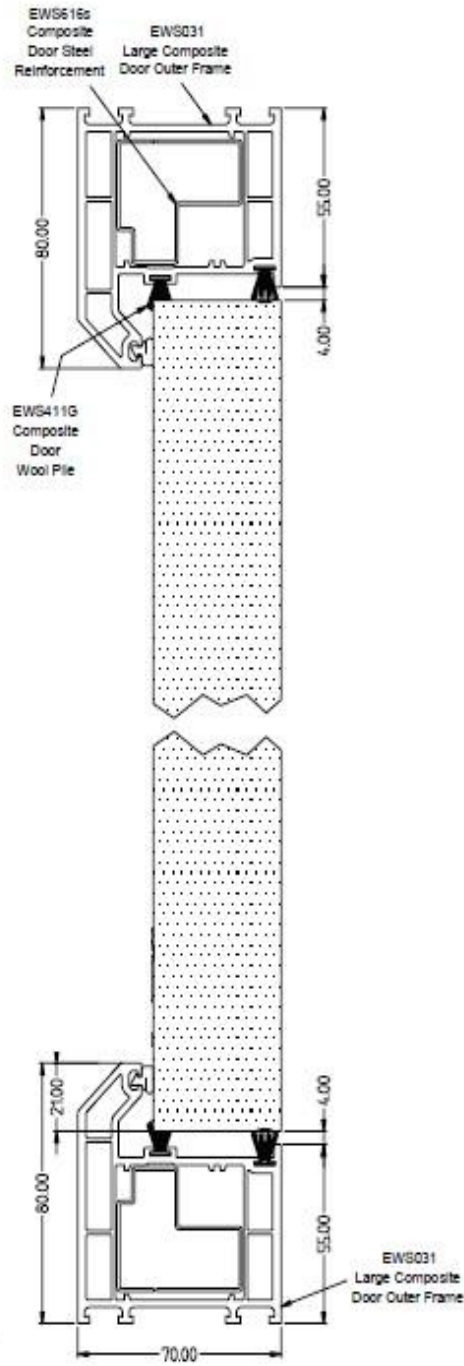
Composite Door System Information

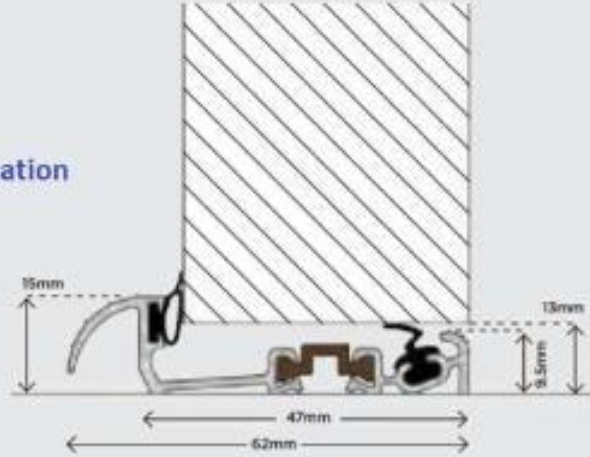
MXS 15/2 RITB

Inward Opening
Available in Gold & Mill Finish
Part M Compliant
Thermally Broken Prevents Condensation
